Flightfax[®]

Online Report of Army Aircraft Mishaps

Mishap Review: NVG Troop Extraction

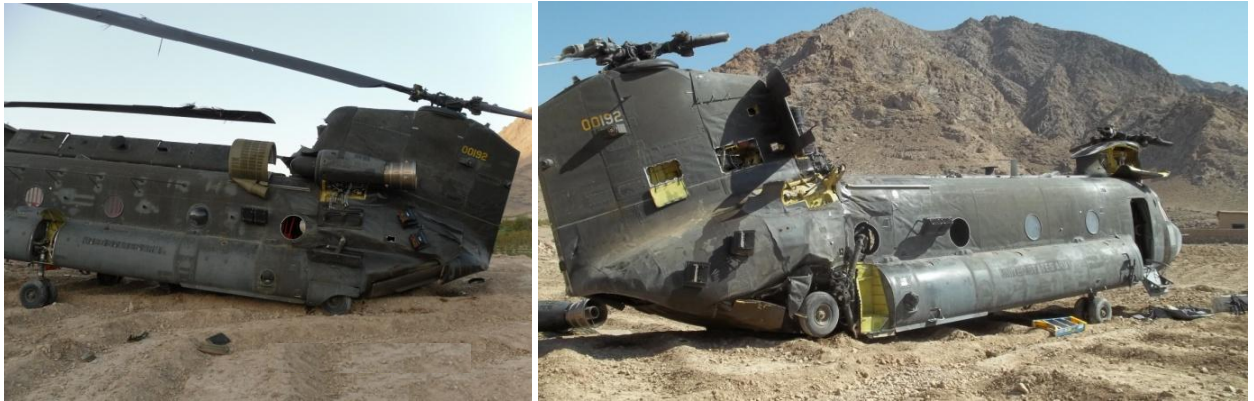
While conducting a NVG troop extraction under zero illumination conditions, the CH-47D landed hard to an unimproved dusty HLZ causing significant aircraft damage and minor injuries to the crew.

The accident board determined that during the approach to the LZ, the PC allowed the rate of descent and ground speed to become excessive for the conditions resulting in the aircraft touching down with an estimated 400-800 fpm rate of descent and 22-26 knots ground speed onto the hard packed, up sloping, and terraced LZ. Additionally, the PI, not on the controls, failed to notify, announce, or otherwise inform the PC of the excessive rate of descent and airspeed condition during the approach. As a result, the aircraft impacted the ground causing damage to the aft landing gear, aft cabin section, and aft pylon section.
